Re: Quapaw Products LLC

Former Cedar Chemical Company, Helena – West Helena, Arkansas

Hazardous Waste Division Technical Branch Trip Report

Arkansas Department of Environmental Quality (ADEQ)
Official Photograph Sheet

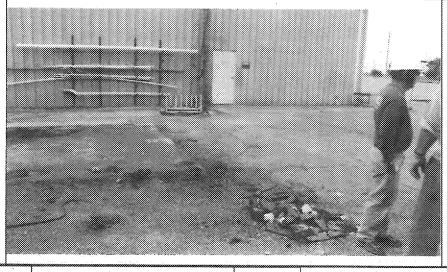
Location:	Ced	edar Chemical Site									
Photograp	A. C	usher		Witness	:	J. Rigg					
Photo #	1	Of	6		Date:	4	/27/2012	1			
Descriptio	Crac	ked asp	halt from pole remov	al		***************************************	Westernoonan

- 1. ADEQ personnel observed cracked asphalt where a pole had been pulled out and holes where the poles of the shed had been cut off. These areas should be patched and filled to prevent seepage of water and potential exposure to the chemicals of concern beneath the asphalt.

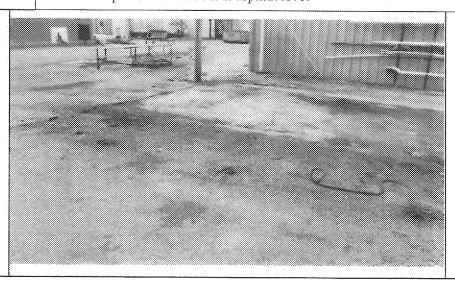
Photographer:					Witness	: J. Rigg	000000000000000000000000000000000000000	
Photo #	2	Of	6		Date:	4/27/2012	Time:	
Description	n:		where	poles were cut off at	asphalt le		decension of the second

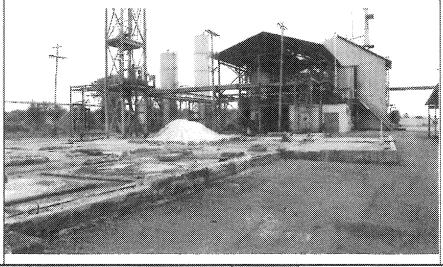
Location:	Ced	edar Chemical Site									
Photograp	A. Cusher			Witnes	Witness: J. Rigg						
Photo #	3	Of	6		Date:	4	//27/2012	Time:			
Description	n:	Cove	ered wa	ste pile	***************************************		***************************************	b	······

- 4. ADEQ was informed that Harcros is working with Clean Harbors LLC to dispose of the waste from renovation of a sump. ADEQ would like updates on the characterization and disposal every two weeks.
- 5. Investigation Derived Waste (IDW) has been discovered at the site by a Harcros employee. Please make arrangements to have the IDW disposed within 45 days of receipt of this letter.

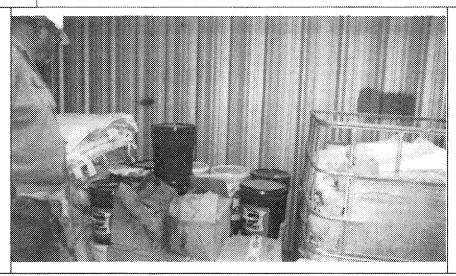
with Clean Harbors for disposal.							
	Mr. Harrington also indicated that Harcross would be							
	running underground utilities when they begin to utilize the							
	unused unit.							
	There are several five gallon buckets of what appears to be purge water (buckets are labeled with monitoring well							
	numbers) still on-site. Harcross would like to know what							
	should be done with the containers.							
	There is a desk and files being moved into the warehouse.							
	Harcross is planning on placing fresh gravel in the boneyard							
	and placing the "loose" equipment into the boneyard to							
	improve the look of the site.							
	There are some empty, damaged containers in a area of the							
	site. Harcross indicated that Enviro Tech has been told to							
TOTAL PROPERTY OF THE PROPERTY	properly dispose if the waste containers.							
L

Photograp	1		usher		Witness	: J. Rigg		
Photo #	4	Of	6		Date: 4/27/2012		Time:	
Description	m:	5 gal	llon con	tainers of purge wate	r			***************************************

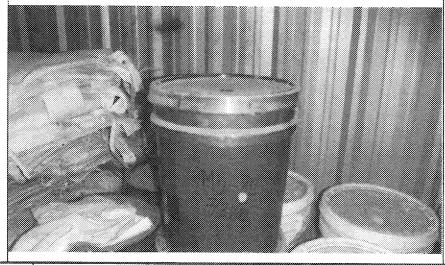
Location:	Ceo	edar Chemical Site									
Photograp	her:				Witness	:	J. Rigg				
	5	1			Date:	4	/27/2012	Time:			
Descriptio	n:	Clos	e up of	gallon container lat	oel		***************************************

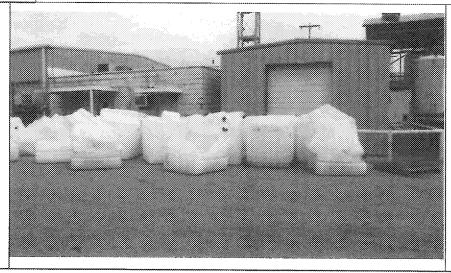
Photographer:					Witness: J. Rigg				
]	Photo #	6	Of	6		Date:	4/27/2012	Time:		
]	Descriptio	m:	Dam	iaged ei	npty containers
